# **Long Term Field Evaluation of High Efficiency Urinals at University of Washington**

Draft Final Report – 5/23/11

Roger E. van Gelder, P.E.

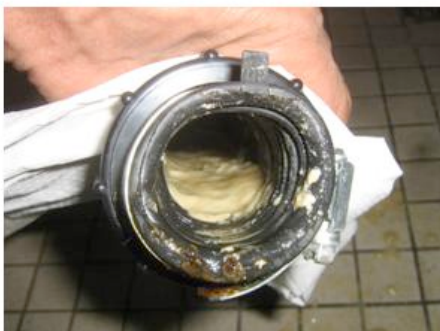
Wall Inlet

Falcon "Waterfree" - Significant deposits

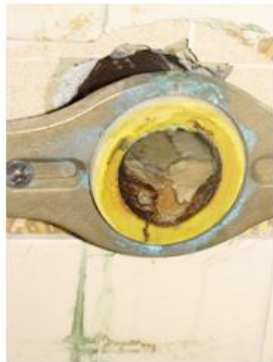
Wall Inlet

**Kohler "Steward" no-water**  
(after 6 months of use)  
Significant deposits

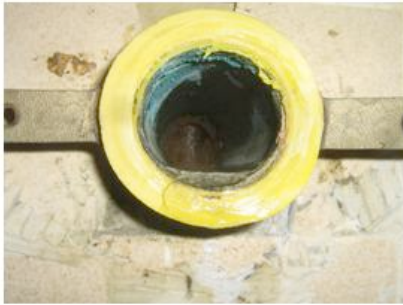
Wall Inlet

Minor deposits

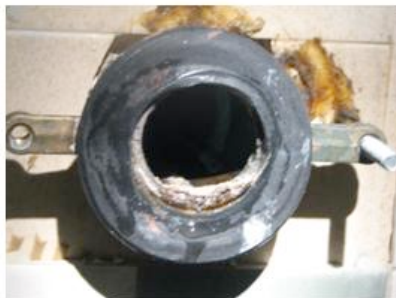
Wall Inlet

Minor deposits

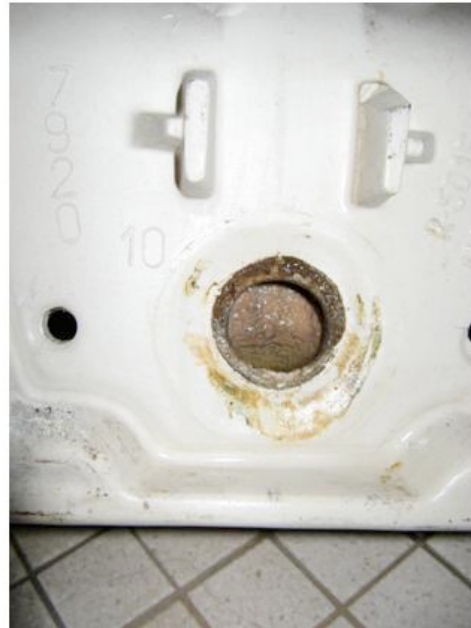
## Kohler "Dexter"

- 0.45 GPF
- Outlet Shows  
No Significant  
Deposits

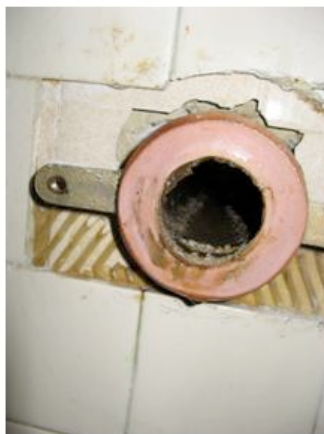
Wall Inlet

## Kohler "Dexter" @ 0.45 gpf Minimal Deposits after 3 Years

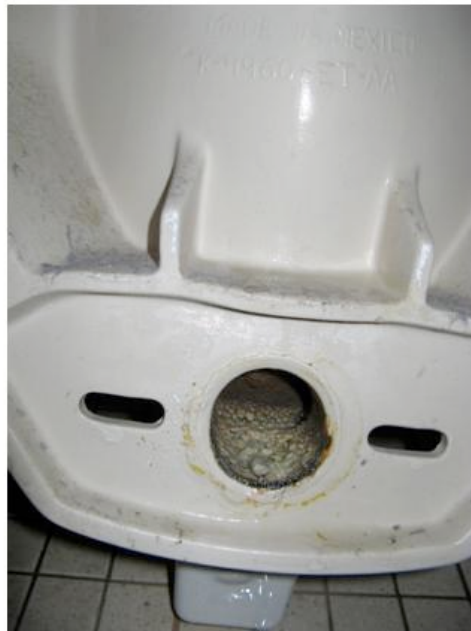
## Kohler "Bardon"

- 0.45 GPF
- Outlet shows slight deposits

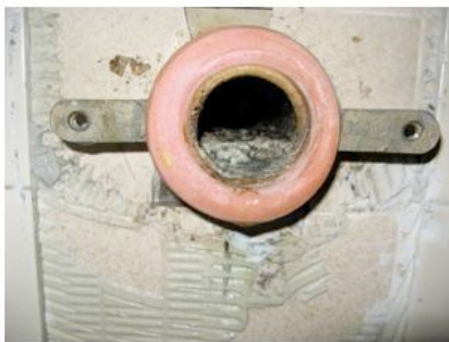
Wall Inlet

## Kohler "Bardon" @ 0.45 gpf Moderate Deposits after 3.5 Years

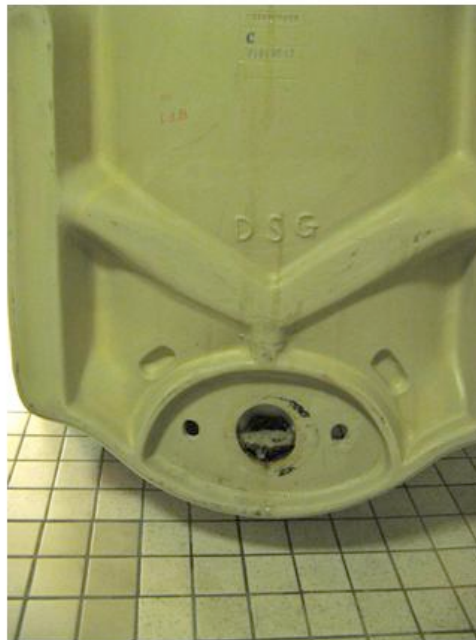
Photos taken in January 2011 show both the horizontal and vertical pipe sections for the Zurn “Pint” 0.125 gpf urinal had become significantly blocked. The horizontal pipe for the Kohler “Bardon” had significantly less deposits and the horizontal pipe for the Kohler “Dexter” showed no significant deposit. The vertical pipes for both the Kohler “Bardon” showed some deposits, but not to the degree seen for the Zurn “Pint”. Note: It is possible that some of the deposits seen in the vertical section for the “Bardon” were in fact left over from when the no-water Kohler “Steward” was installed here. For this floor only, the vertical section had not been replaced. Instead, a removable section of the vent pipe was installed just above to allow viewing of where the horizontal waste line entered the vertical line.

## Zurn “The Pint”

- 0.125 GPF
- Outlet 50% Blocked after 3.5 Years

At this point it appears that UW has decided to discontinue installation of any new pint flush urinals and increase the flush volume of those already installed to one half gallon. New installations of half gallon flushing urinals will continue.

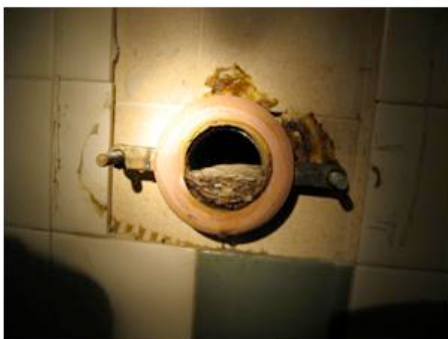
Wall Inlet

Significant Deposits after 3.5 years
