TOILET FIXTURES

Long-Term Durability Test

**The Metropolitan Water District
of Southern California**

May 2001

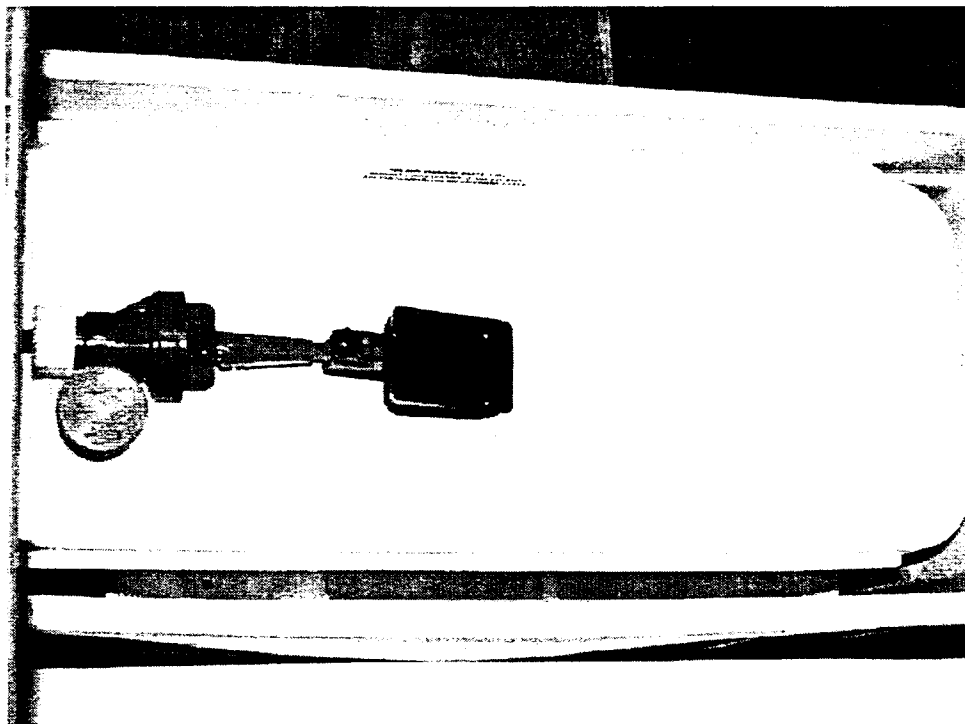
Niagara Model 2216 (flapperless) – (Figure 2)

All four units of this model periodically experienced problems with the water containment vessels (WCV) within the tank being stuck in a dumping position (tipped at an angle from their normal resting position). This resulted in the fill valve remaining open while the toilets ran continuously. It appeared to lab personnel that this was caused when the edge of the tipped WCV was in slight contact with the side of the tank or its lid, thereby "sticking" and preventing it from returning to its at-rest position. In addition, it appeared that this occurred only when the flush handle was depressed for the period of two seconds. When this occurred, merely touching the flush handle caused the bucket to "break loose" and return to its at-rest position.

Lab personnel were not able to adjust the early units (#1 and #2) of this toilet model to the 1.6-gpf setting. Representatives of Niagara were called into the lab to investigate and concurred that these two units were experiencing problems caused by factors external to the lab tests. They arranged for two additional units (#3 and #4) to be tested; Metropolitan personnel selected units #3 and #4 at random from the Niagara warehouse in Santa Fe Springs. According to Niagara representatives, these subsequent units had been assembled at that new Santa Fe Springs location under more strict quality control procedures. Both of the new units were easily adjusted to the correct 1.6-gpf setting.

The Niagara #1 unit leaked through the flush handle opening in the tank for about the first 125,000 flush cycles. The leak volume was such that it was sufficient to result in a puddle on the floor of a residential bathroom. By 150,000 flush cycles, this problem had disappeared. Lab personnel attributed this "self-sealing" to the build-up of a mineral formation at the leak location.

Figure 2. Top view of Niagara® showing Fluidmaster fill valve and water containment vessel

All four Niagara toilets found with WCV stuck in a partially cocked position (WCV tipped at 90 degrees). Water was running because fill valves could not be closed. No explanation for this. The lids were removed and the units inspected. They appear to be otherwise operating normally.

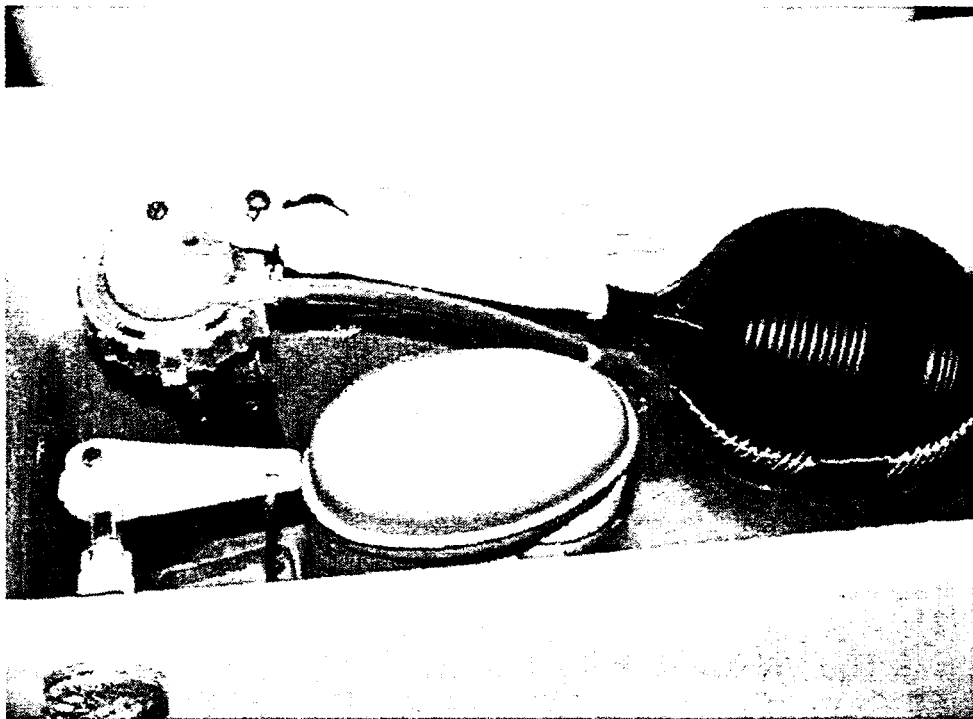
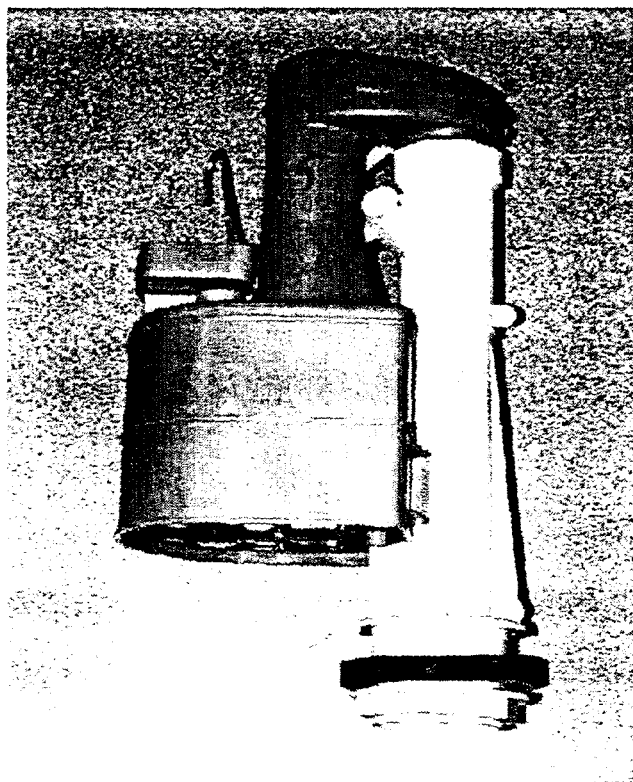
Western Pottery Flapperless Siphonic ("Turbo-Siphon") – (Figures 3 and 4)

Only one of this model was tested. This unit was taken out of service at 103,387 flush cycles because of a broken return spring. A representative of the Turbo-Siphon flush valve (manufactured by Thomas Dudley Ltd., Dudley, England) provided a replacement spring, lab personnel re-assembled the siphonic unit, and the toilet was put back into service on the test apparatus at the next 25,000 cycle shut-down. The toilet was out-of-service for approximately two weeks. Turbo-Siphon flush valves or replacement parts are not available at retail plumbing supply houses.

In addition, at the 128,387 flush cycle point, lab personnel observed that the yellow retainer pin began to work its way out of the assembly. It was pushed back in to its original position by those personnel. Later (at 137,000 flush cycles), however, the pin had worked its way completely out of the assembly and the siphonic flush valve was inoperable. The pin was re-inserted by lab personnel and for the remainder of the test, it continued to work its way out; lab personnel then periodically pushed it back into position so that the toilet could finish the entire test process.

Figure 3. Turbo Siphon flush valve installed inside Western® toilet

Figure 4. External view of Turbo Siphon flush valve

Western continues to stick. Unit disassembled. Return spring is bent out of shape and not working. Unit taken out of service at 103,387 flushes. Replacement for broken part requested from manufacturer.

Western - yellow pin that holds Turbo-Siphon flush valve to overflow tube had worked itself out. It was pushed back in. This has been observed before but not reported.

9-12-0 Yellow pin on Western Turbo-Siphon had come completely out. Flush valve unit was free floating. Pin re-engaged. Unit resumed flushing.

Spring replaced in Western Turbo-Siphon. Unit brought back on line.

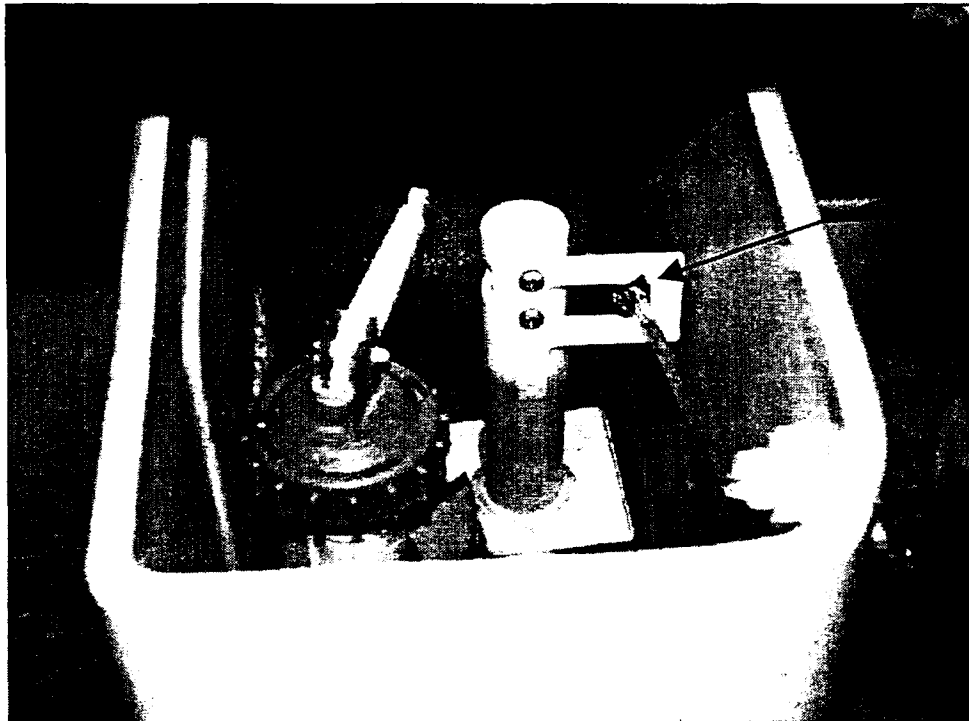
Two of this toilet model were tested. Except for different fill valves (refer to Table 1), the units were identical. The toilet uses a piston-type flush valve.

Difficulty was experienced by lab personnel at initial set-up in adjusting the units to flush at 1.6 gpf. Later, at about 100,000 flush cycles, adjustments were required to both units to re-set the water level. After 250,000 flush cycles, some minor wear to the lift bar on the piston (plunger) was observed (see Figure 2). This wear did not affect the performance of the toilet. No other significant problems or anomalies were experienced with the Legend toilets during the test.

Figure 5. Legend® #1 tank, showing WDI fill valve (blue) and piston-type flush valve (note wear pattern on the lift bar)

Legend #1 flushing at 2.08 gpf as received. Unit filling exactly to red “WL” mark as received. No adjustment made.

Legend #1 had to be adjusted. Unit was filling above the water line. Adjusted to the maximum and still filling 1/4-inch past indicated "WL".
Same for Legend #2.

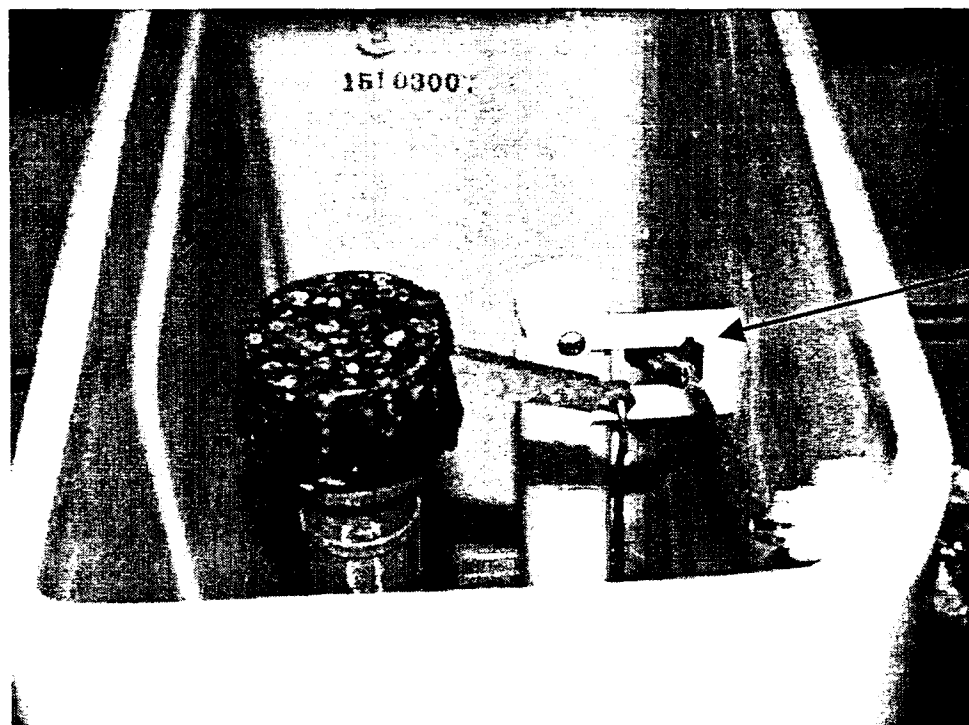
Figure 6. Legend® #2 tank, showing Fluidmaster fill valve (black) and piston-type flush valve (note wear pattern on the lift bar)

Legend #2 flushing at 2.74 gpf as received. Fill valve did not shut off until water was overflowing into overflow tube. Unit adjusted to red “WL” mark. Flushes at 1.98gpf. Unit could not be adjusted to molded “WL” mark as fill valve adjustment is “bottomed out”.

09-27-00 Legend #2 lift mechanism had risen past its stop and come loose. It was re-installed.

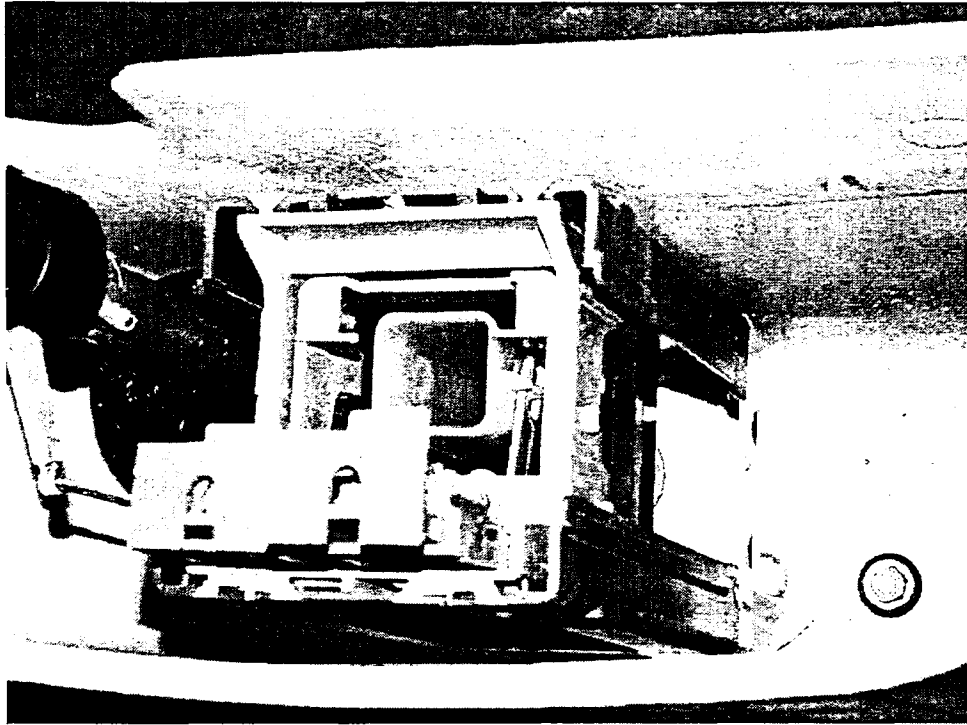
Caroma Caravelle 305 Dual Flush – (Figure 7)

Only one of this model was tested. The Caroma dual-flush toilet is manufactured and widely used throughout Australia. The unit provides the user with two flush volumes: 0.8 gpf for liquid only and 1.6 gpf for a full flush. The flush is activated by pressing either one of two buttons located on top of the tank. The flush option used for the test was the 1.6 gpf setting. No problems or anomalies were experienced with this toilet and it maintained full integrity during the entire 250,000 flush cycle program.

Figure 7. Fluidmaster fill valve (left) and dual-flush mechanism (right)
inside Caroma Caravelle toilet
