An Assessment of  
Long-Term Performance of Non-Water (Waterfree) Urinals  
in Relation to Drain Line Buildup

Falcon Waterfree Technologies and  
Sloan Valve Company  
September 15, 2008

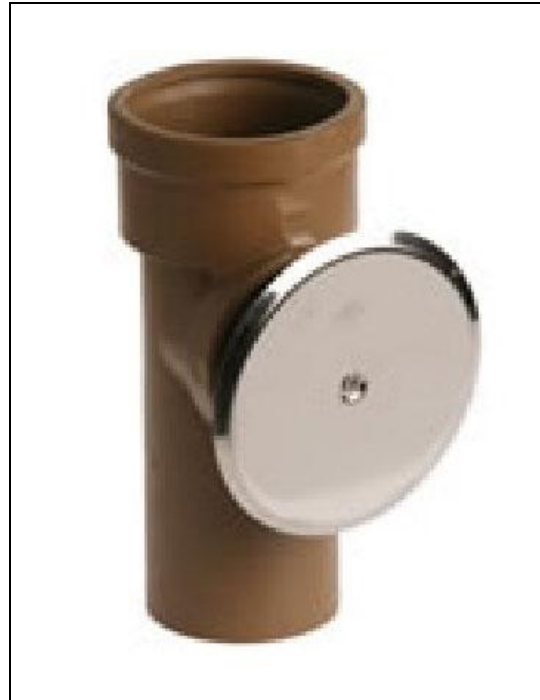
Figure 1. Drain pipe fitting with a clean-out plug.

Clean-out plugs (see Figure 1) are common, commercially available drainage system components that provide access for removal of drain line blockage, minimizing the need for invasive remediation that could include demolition of walls and replacement of drain pipes. Plumbing code officials have demonstrated foresight with regards to the potential detriments of blocked drainage systems by establishing codes that require the installation of clean-out access throughout sanitary systems, which allow for periodic cleaning and clog removal. In addition, plumbing codes also require placement of clean-out plugs in specific, strategic locations where frequent clogging is known to occur, such as at urinal fixtures (see Table 1).

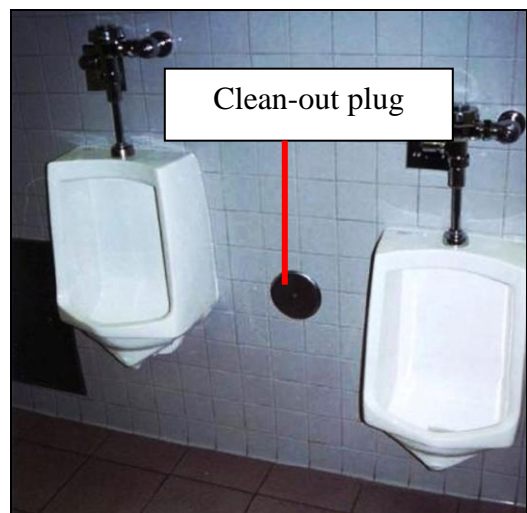
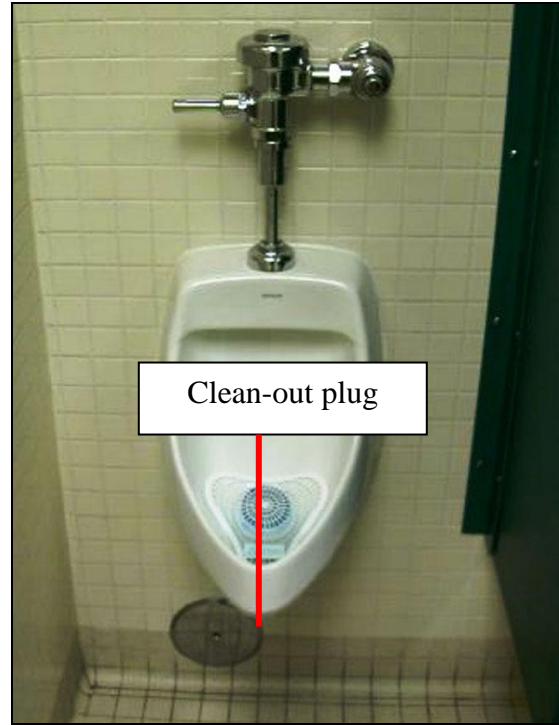
Figure 2. Clean-out plug examples.

Figure 3. Clean-out plug example.

Figure 4. Clean-out plug examples.

Figure 5. Clean-out plug example.

Figure 6. Clean-out plug examples.

Clean-out plugs on water-flushing urinal drain lines are usually visible on restroom walls where plumbing chases are not accessible (see Figures 2-6).

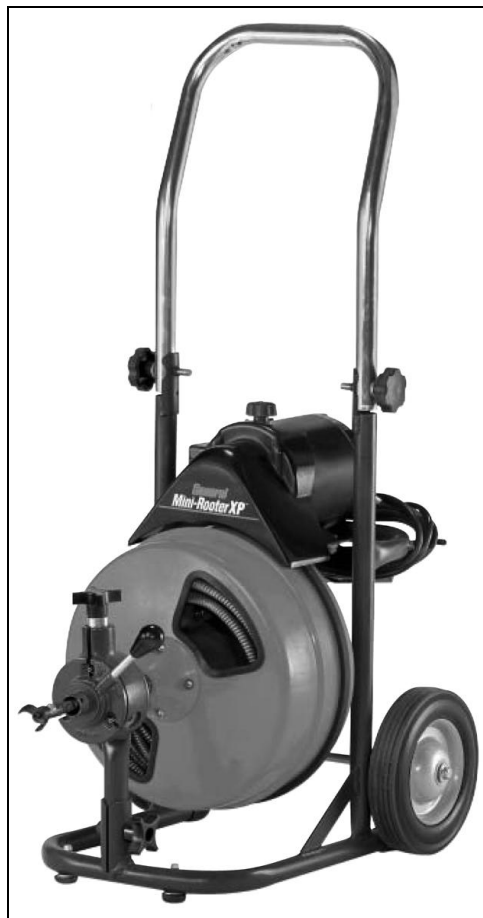
Figure 7. Drain machine.

Water-flushing urinals produce calcite buildup in the urinal bowl and drain pipes. Calcite buildup is solid in consistency, bonds to the pipe wall, and can only be removed by accessing the drain pipe through a clean-out plug using a drain machine (see Figure 7) with cutter heads to remove the hard deposits.

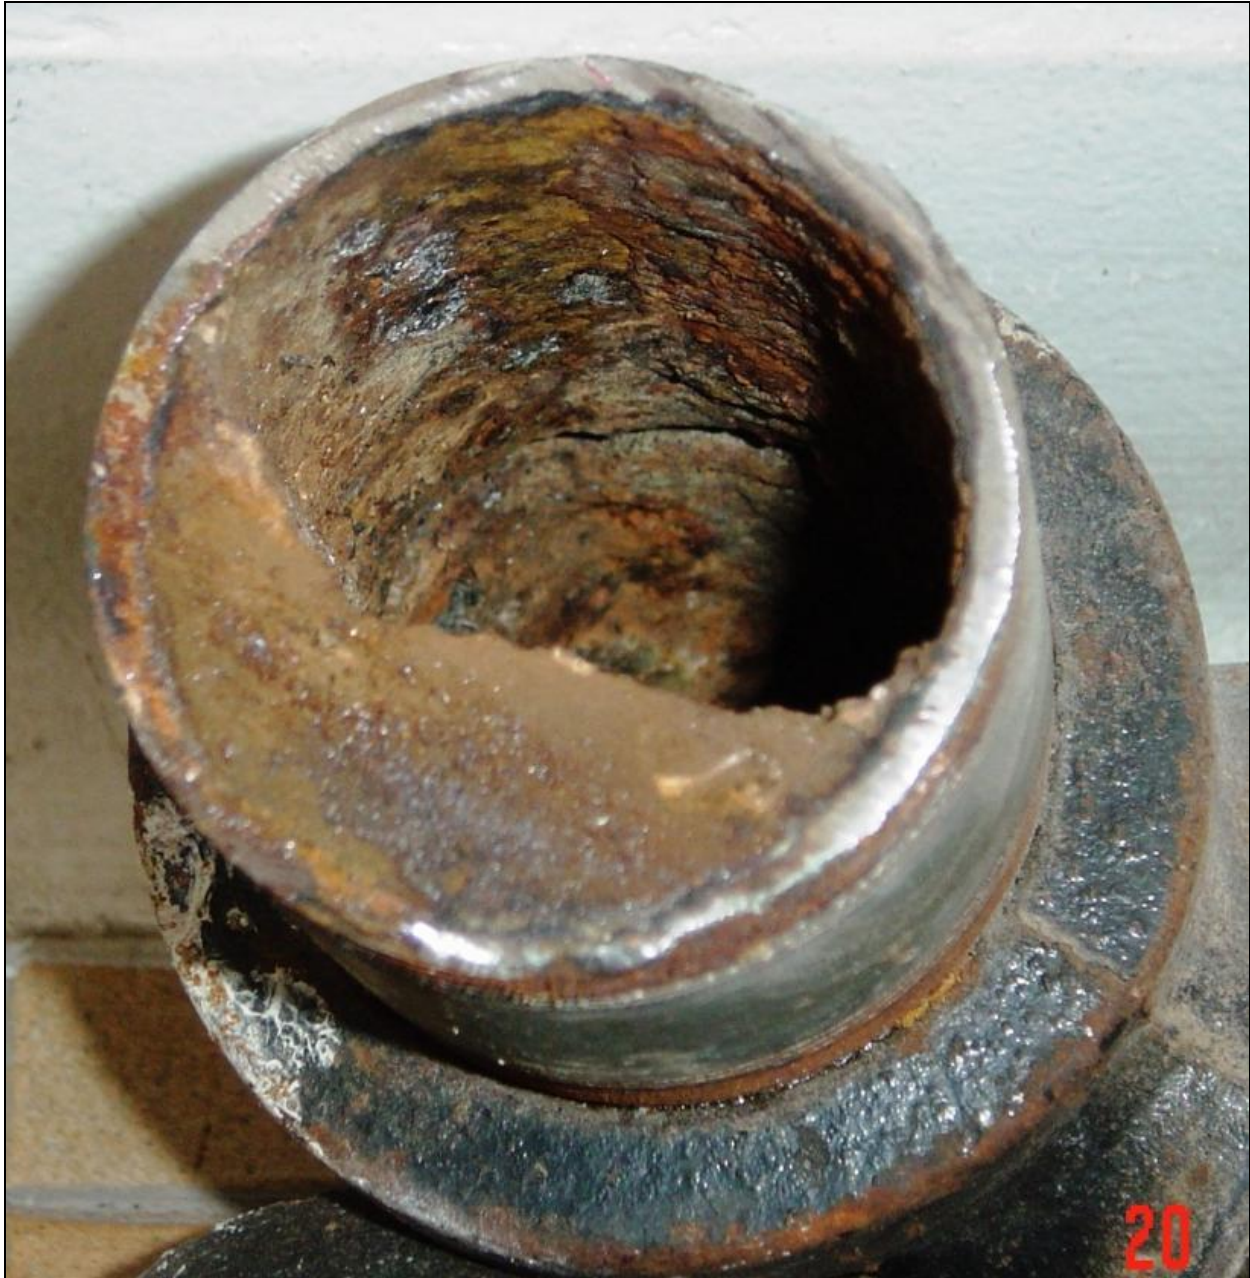
Figure 8. Drain pipe for water-flushing urinal at Fort Bliss in El Paso County, Texas, removed after 8 years of service.

The cause for this hard buildup in water-flushing urinals is due to mineral ions in flushing water combining with the sediment in urine. A chemical bond is formed between the flushing water minerals and the urine sediment to form a hard calcite buildup inside the drain pipe. The addition of flushing water to urine sediment is similar to adding a catalyst or hardener to a resin or glue.

Examples of drain pipes sections that served water-flushing urinals are shown on the following pages (see Figures 8-15).

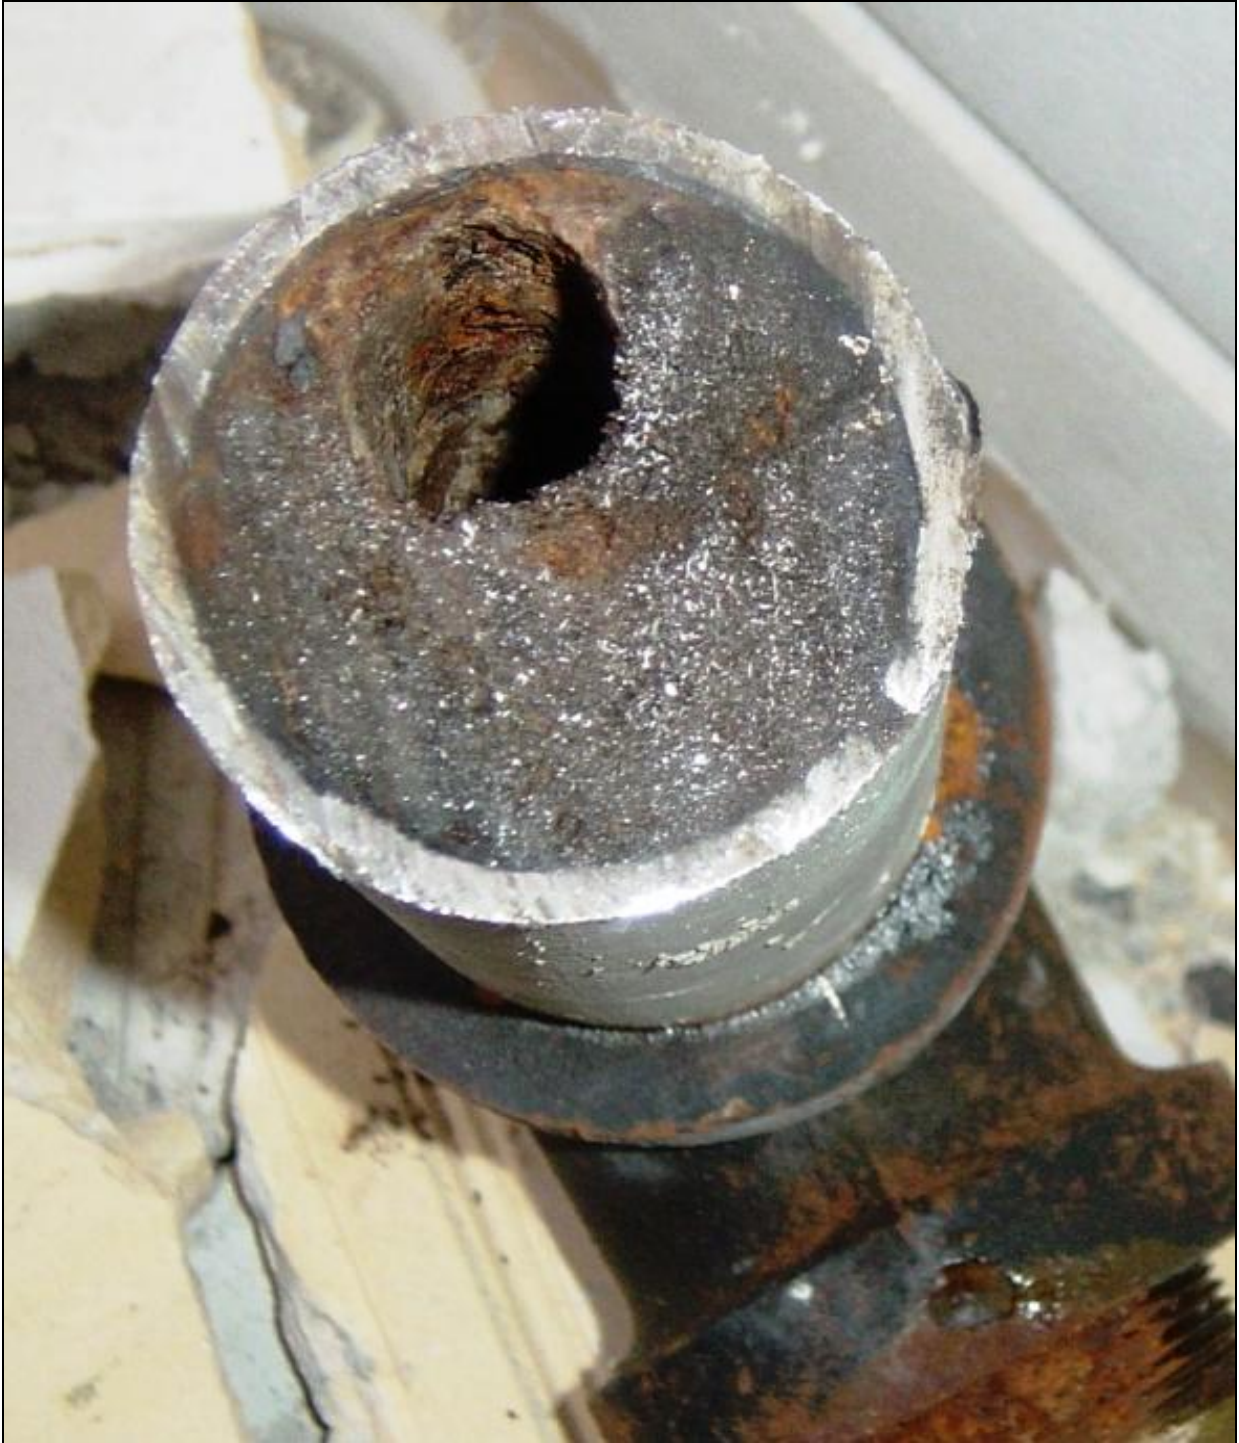
Figure 9. Drain pipe for water-flushing urinal at Fort Bliss in El Paso County, Texas, removed after 8 years of service.

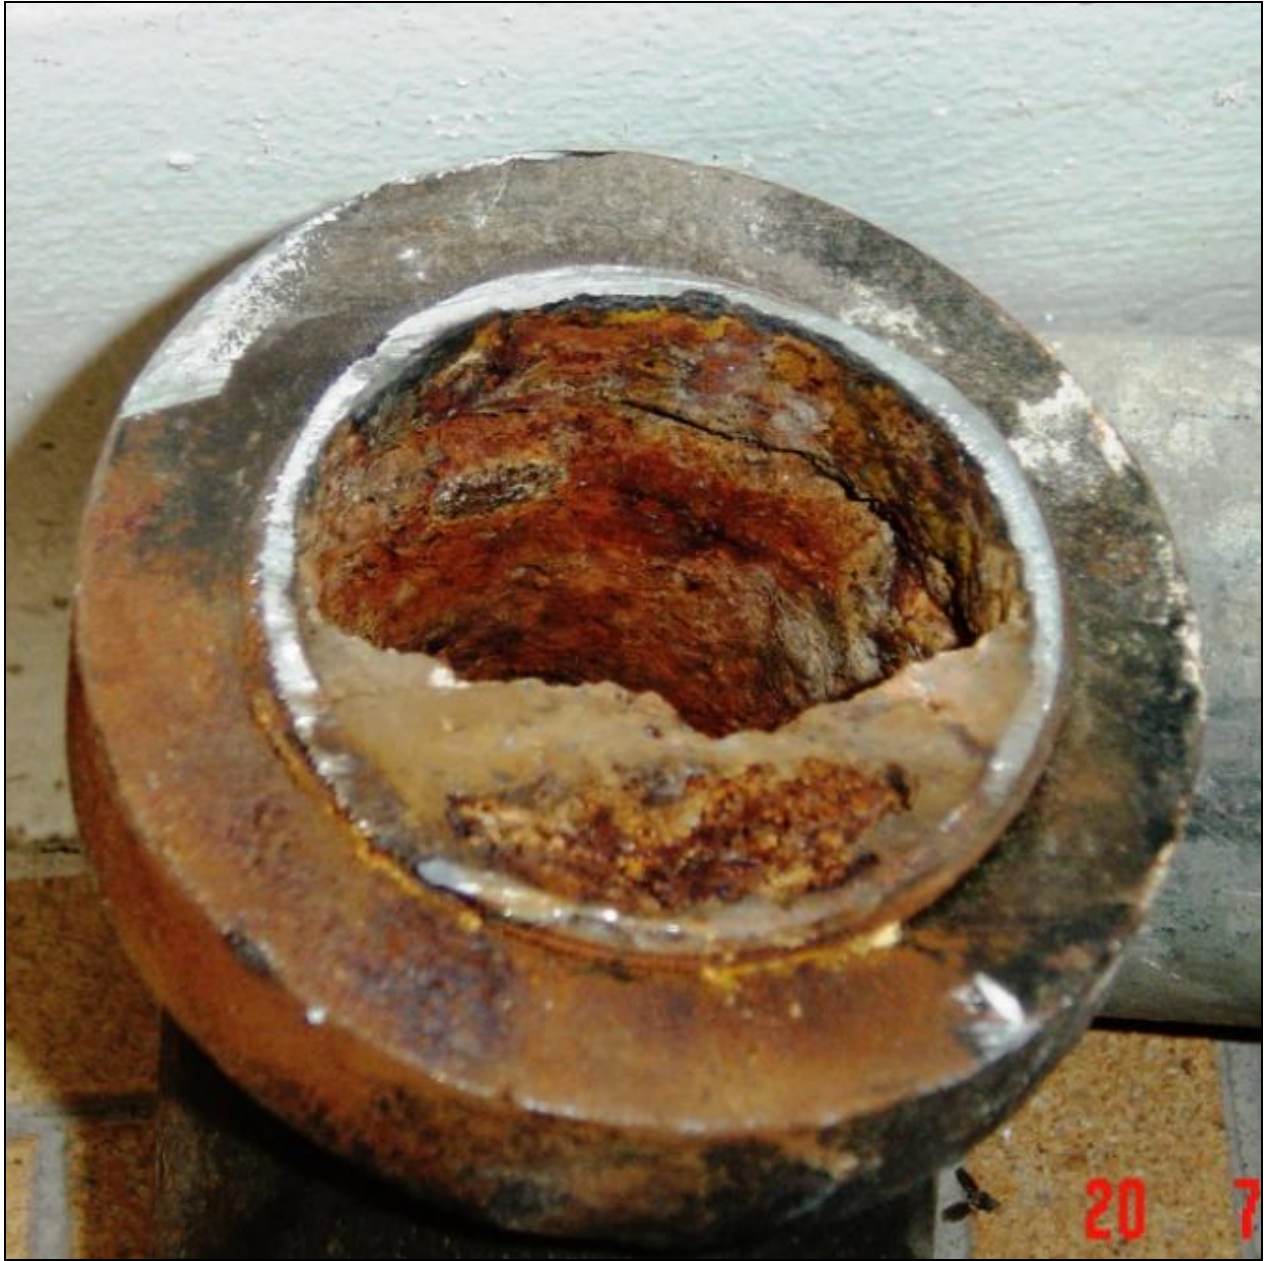
Figure 10. Drain pipe for water-flushing urinal at Fort Bliss in El Paso County, Texas, removed after 8 years of service.

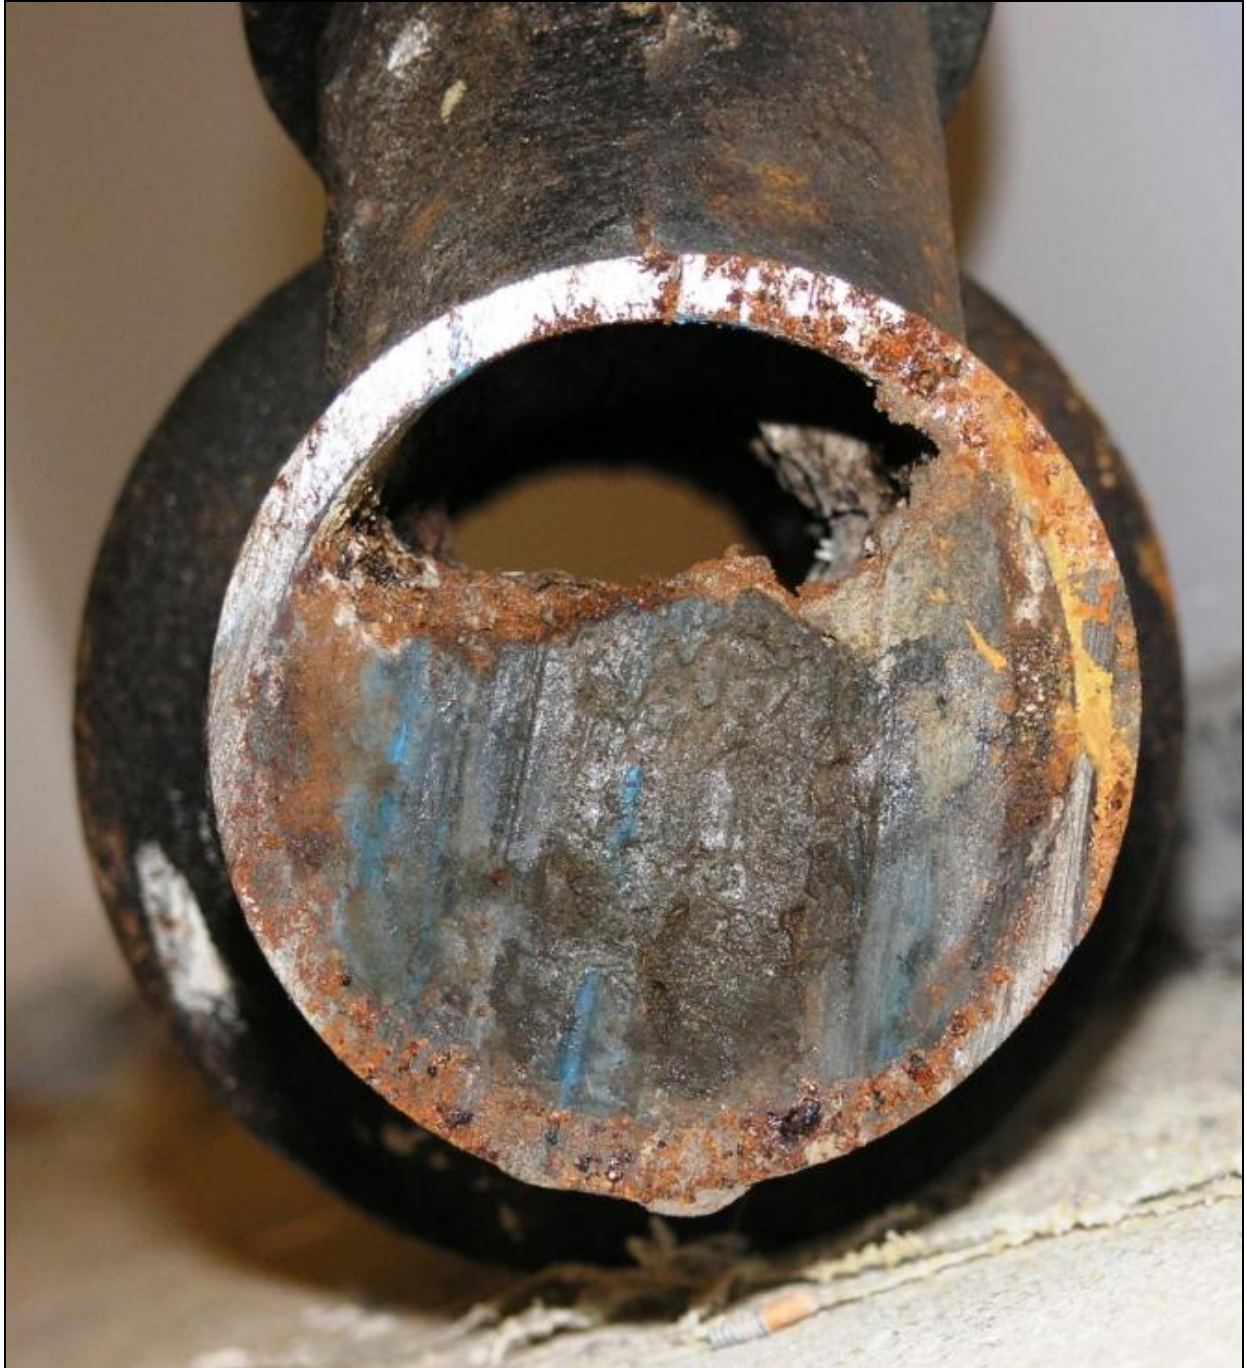
Figure 11. Horizontal fixture run, directly beneath water-flushing urinal at Aquinas College in Grand Rapids, Michigan, removed in 2005 after 12 years of service.

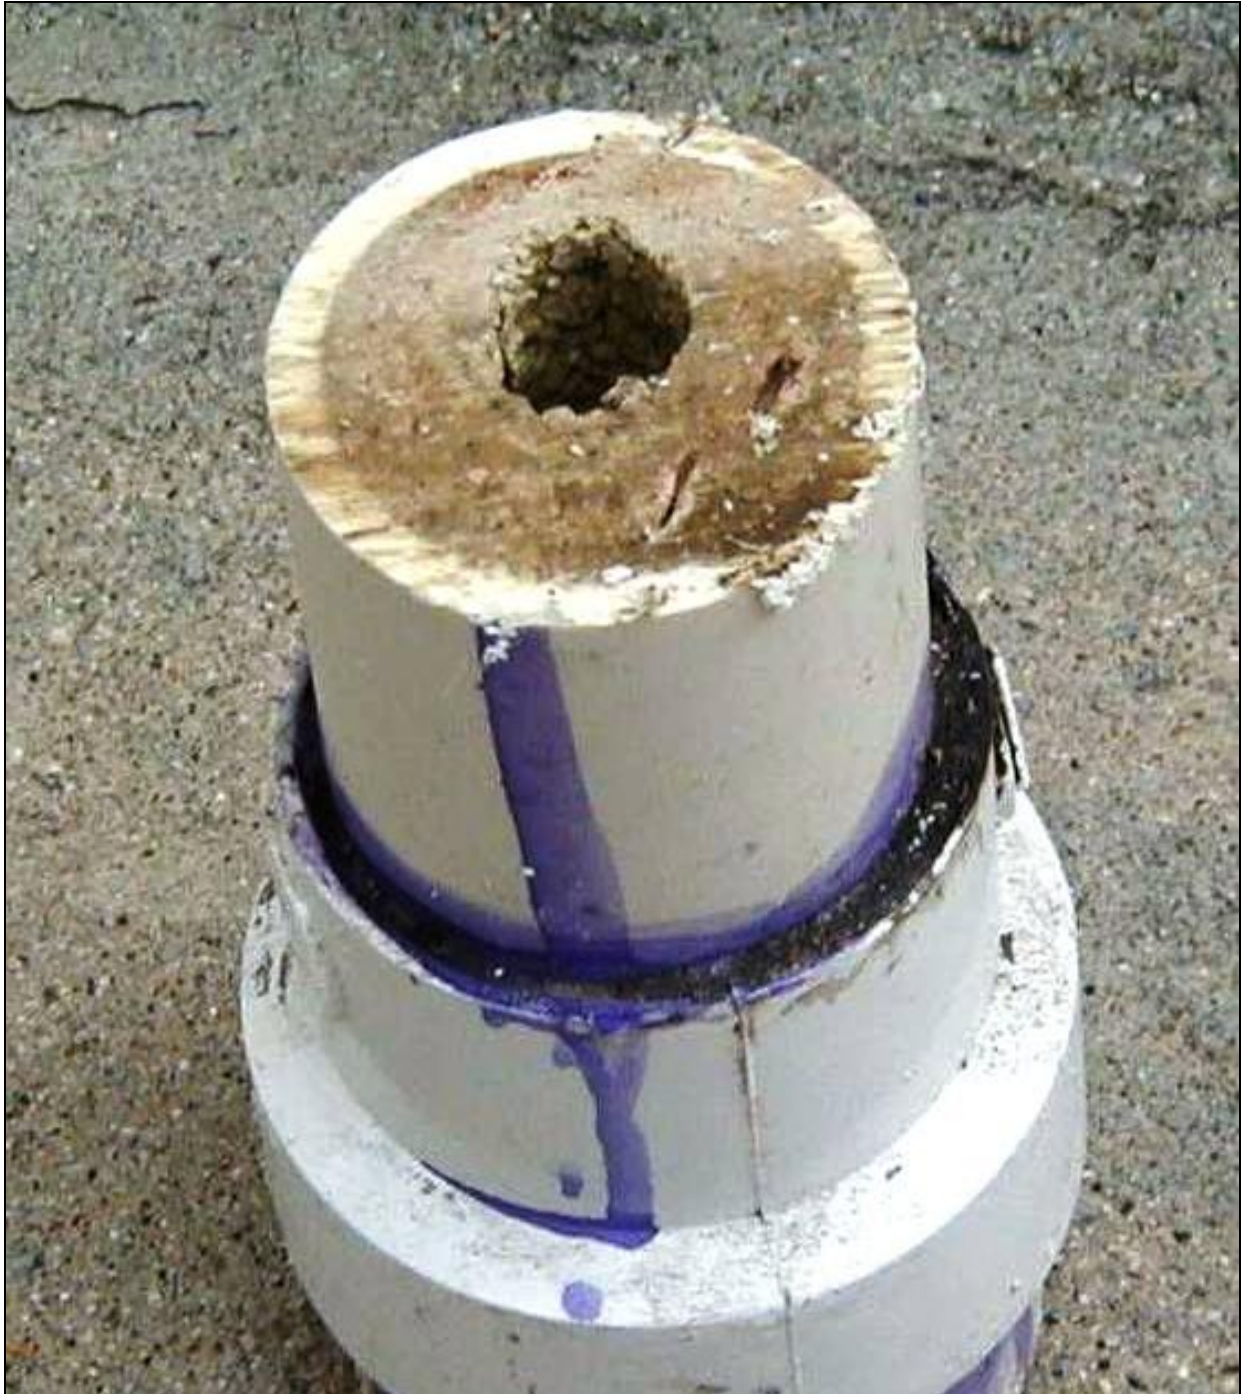
Figure 12. Vertical stack drain pipe for water-flushing urinal at Lackland Air Force Base in San Antonio, Texas, removed after 24 months of service.

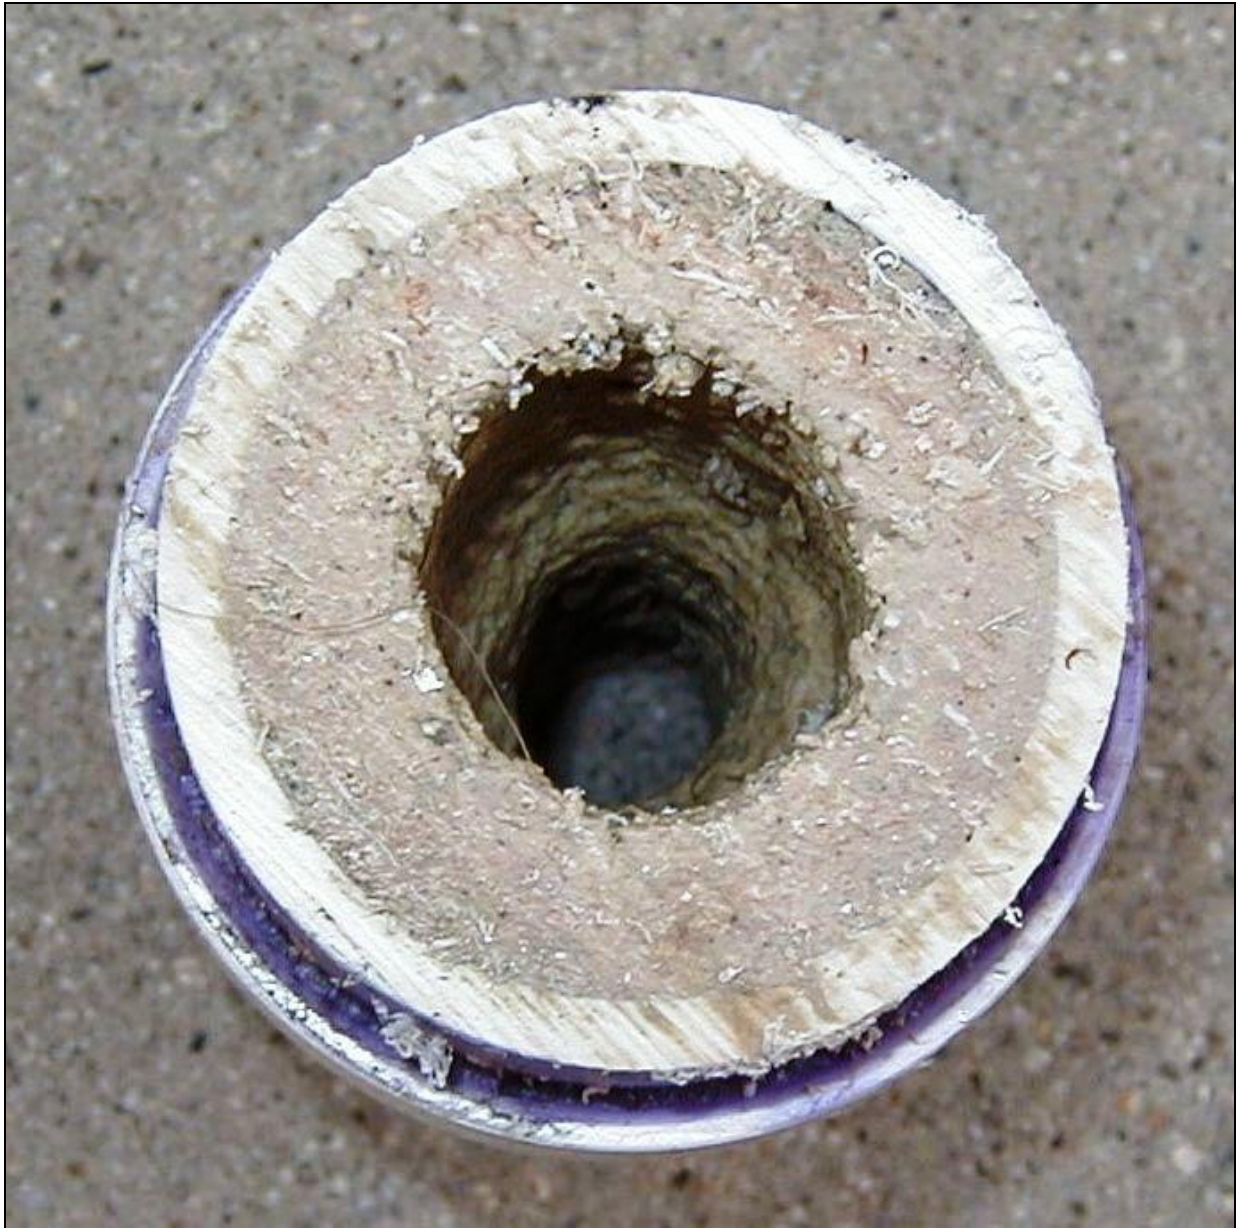
Figure 13. Vertical stack drain pipe for water-flushing urinal at Lackland Air Force Base in San Antonio, Texas, removed after 24 months of service.

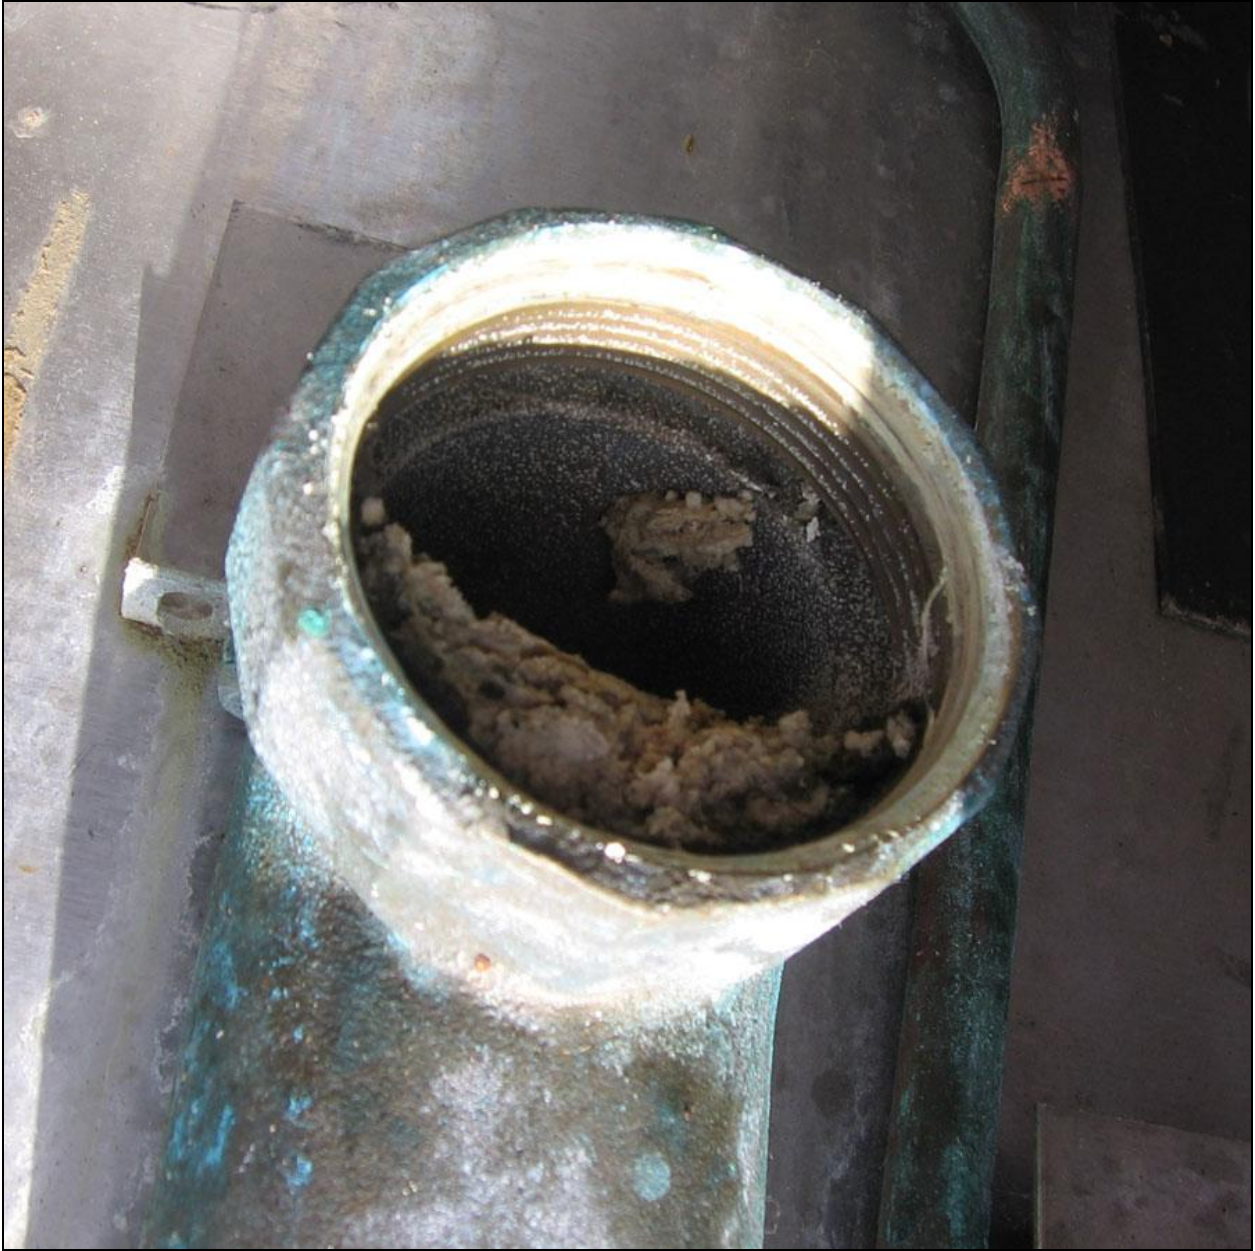
Figure 14. Urinal outlet for water-flushing urinal at Los Angeles County Beaches, removed after 3 years of service.

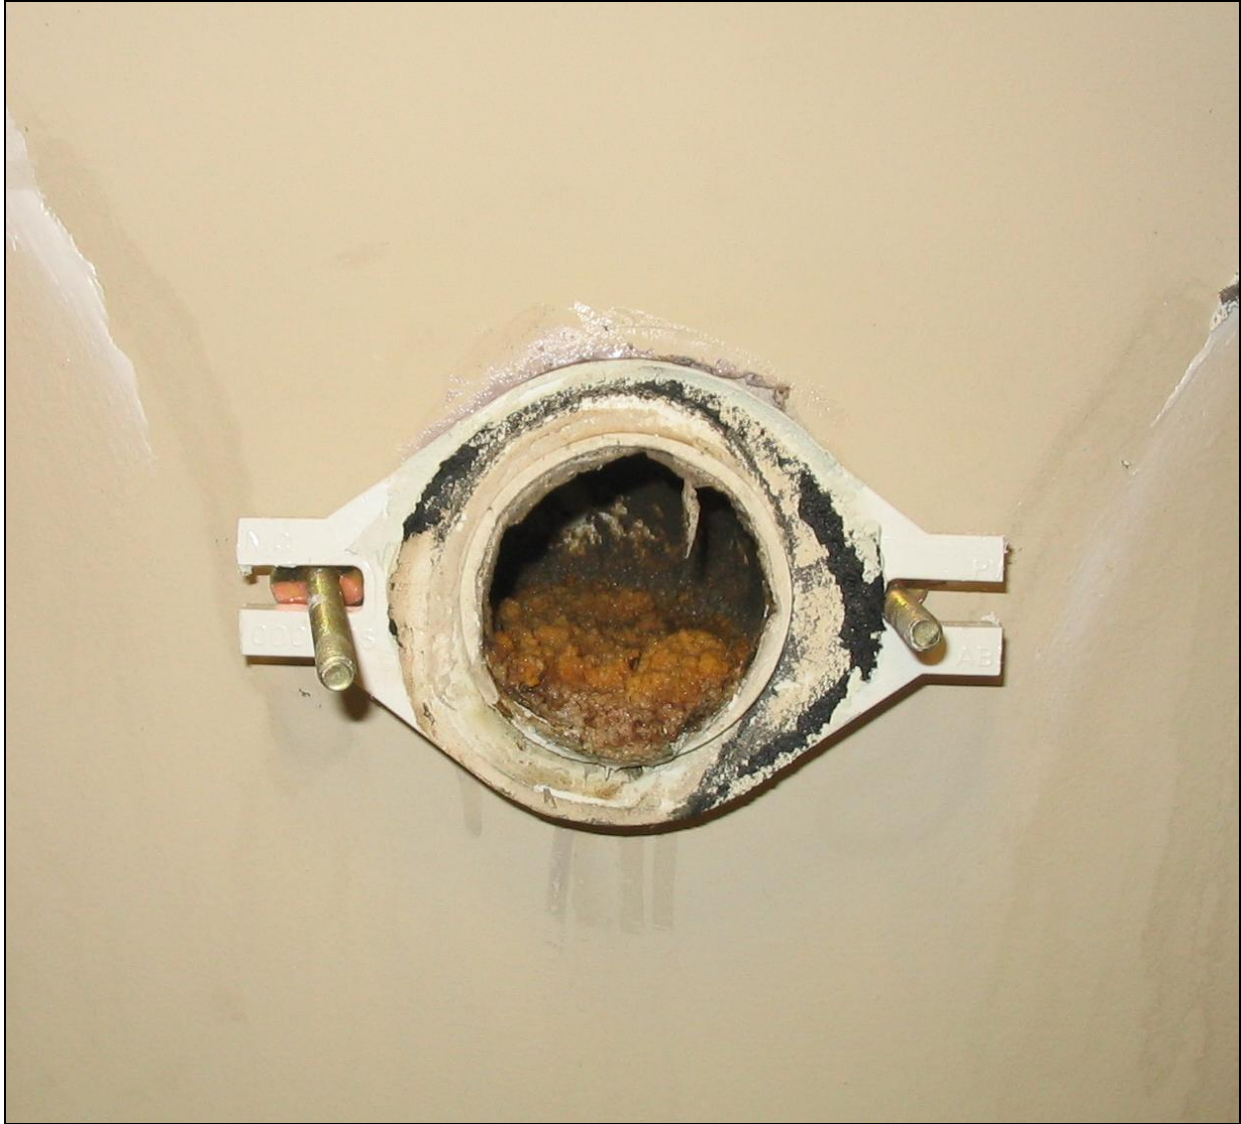
Figure 15. Horizontal pipe nipple/drain connection in 2005 after removing a water flushing urinal that had been in operation for less than five years at CPR in Grand Rapids, Michigan.

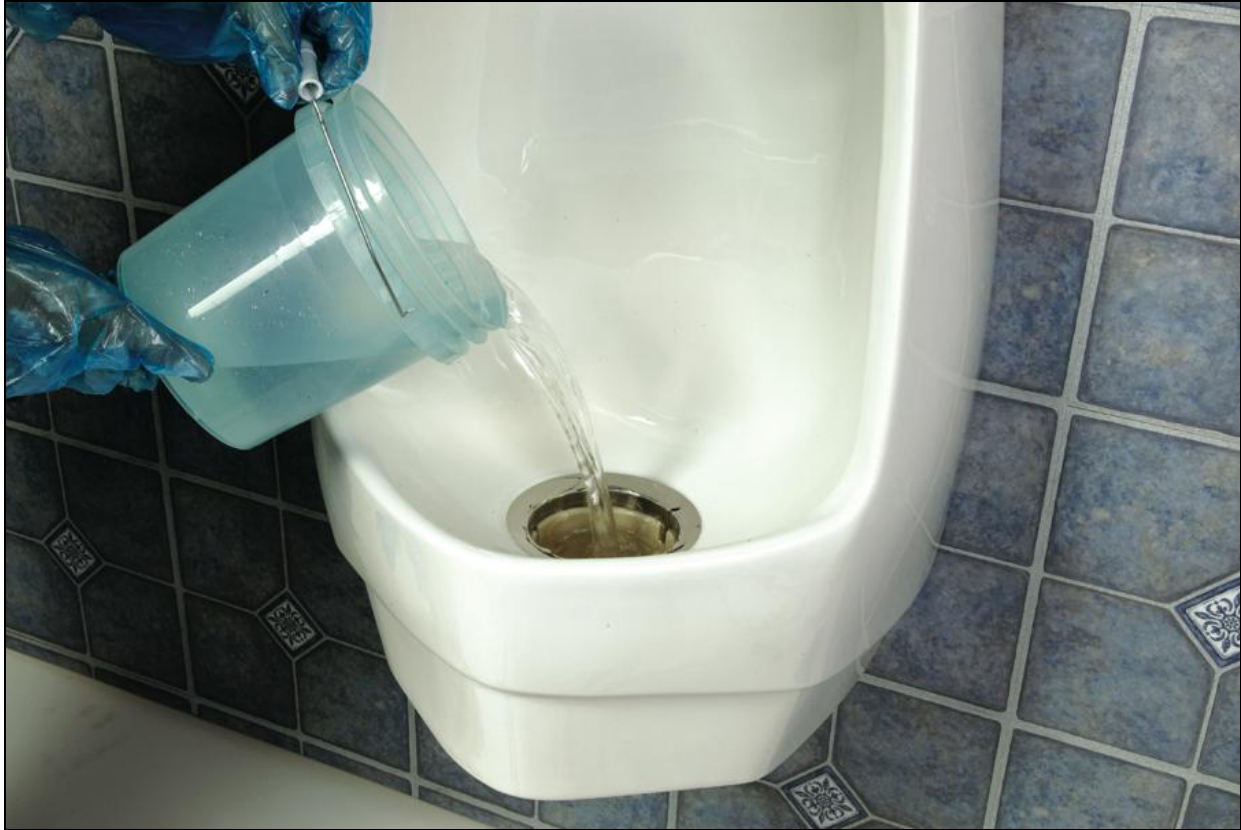
Figure 17. Pouring water into a non-water urinal system to clean drain pipes.

The sealed cartridge trap of a non-water urinal acts as a sediment catch, reducing the amount of sediment entering the drain pipe. Manufacturer specified maintenance procedures for cartridge replacement include pouring a bucket of water (see Figure 17) into the system, which removes loose and soft sediment from the pipes. Sediment from undiluted urine in the drain pipe remains soft and does not form hard buildup like water-flushing urinals. This is because there is no

Non-water urinals that use removable cartridges provide a large opening for efficient and effective flushing of the system during routine maintenance (see Figure 17).

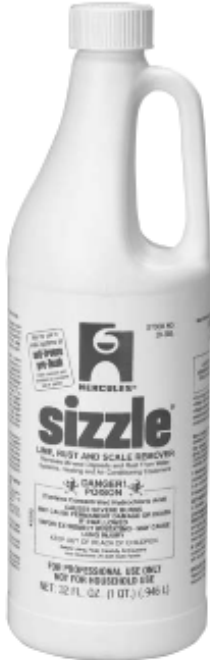
Figure 19a. Sizzle Lime, Rust, and Scale Remover, product information sheet page 1.

**DESCRIPTION**

Removes scale, salts, mineralized deposits, slime, and corrosion to clean heating, cooling, plumbing equipment and tools. Does not contain phosphates.

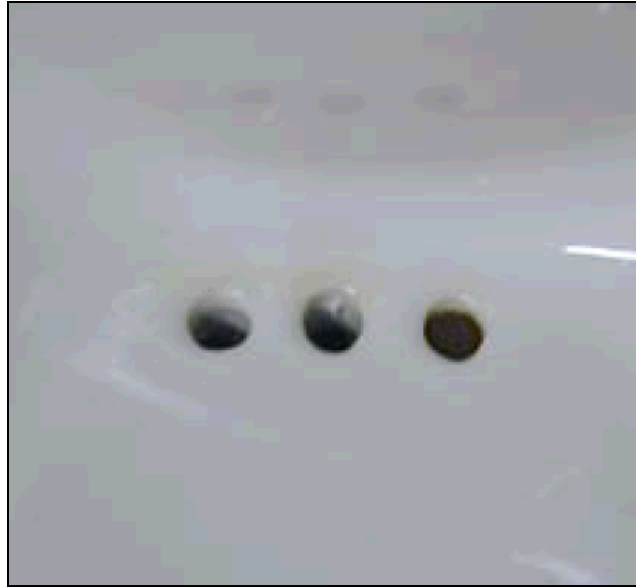
Figure 20. Drain holes in the bottom of the bowl in a Duravit non-water urinal.

Duravit recommends periodic flushing as part of the standard maintenance procedure for Duravit non-water urinals. Due to the fact that the Duravit urinal has an integral trap-way with no service access, the fixture can only be flushed through 3 drain holes that measure approximately 1/4 inch

diameter (see Figure 20). The small drain holes do not allow flushing sufficient enough to clear the trap-way or drain pipes.

The addition of sealant oil to the Duravit fixtures is noted in the report, but no mention is made of Duravit’s recommended maintenance procedure of flushing with 5 gallons of water each month. Even if flushing did take place, the small drain holes in the Duravit fixtures do not allow adequate flushing and soft buildup is allowed to accumulate and eventually clog the drain pipe.

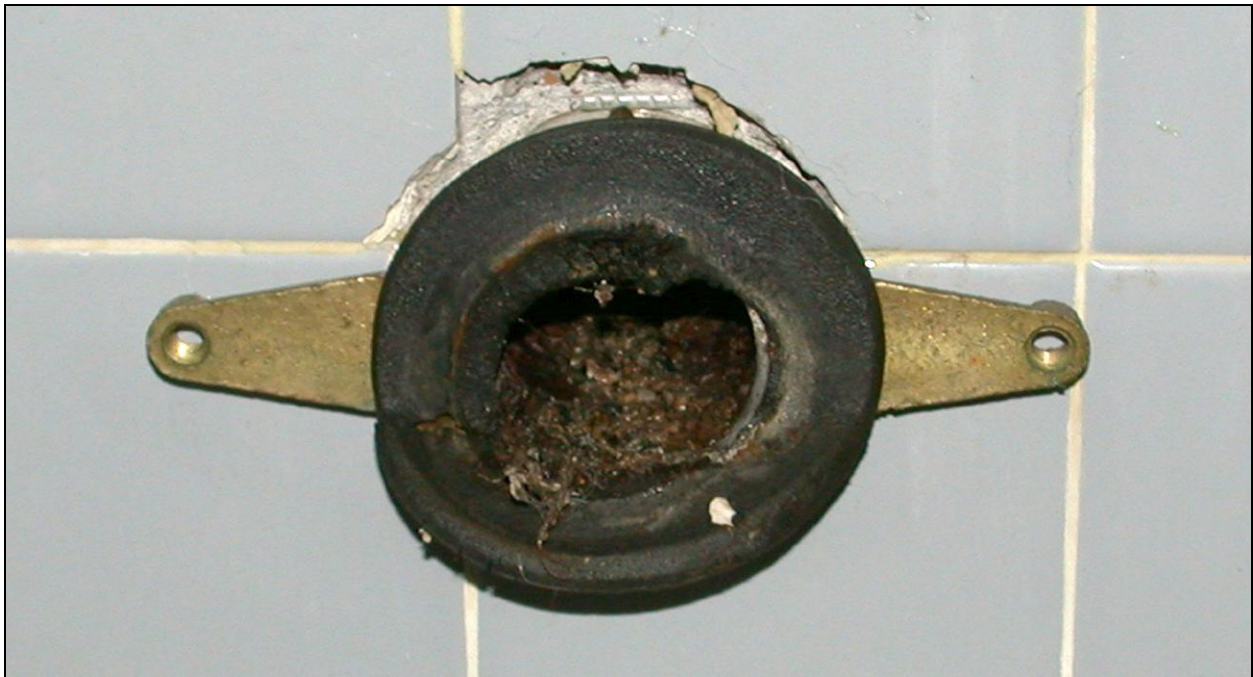
Figure 21. St. Louis County Health Department, 2003. Drain line after removing water flushing urinal that had been in service for 21 months.

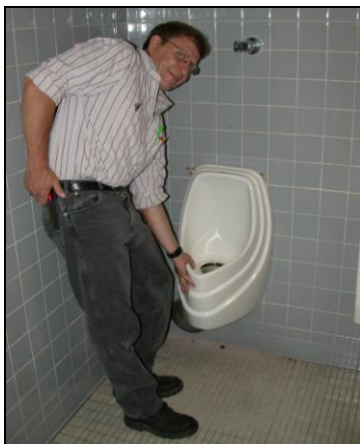
Figure 22. St. Louis County Health Department, 2003.  
Completing the installation of a Falcon Waterfree urinal,  
replacing the water-flushing urinal.

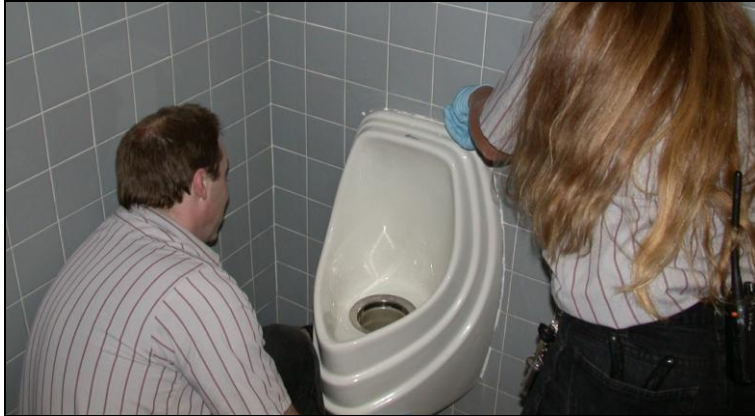
Figure 23. St. Louis County Health Department. Removing the Falcon Waterfree urinal to inspect the drain line after one year of continuous operation.

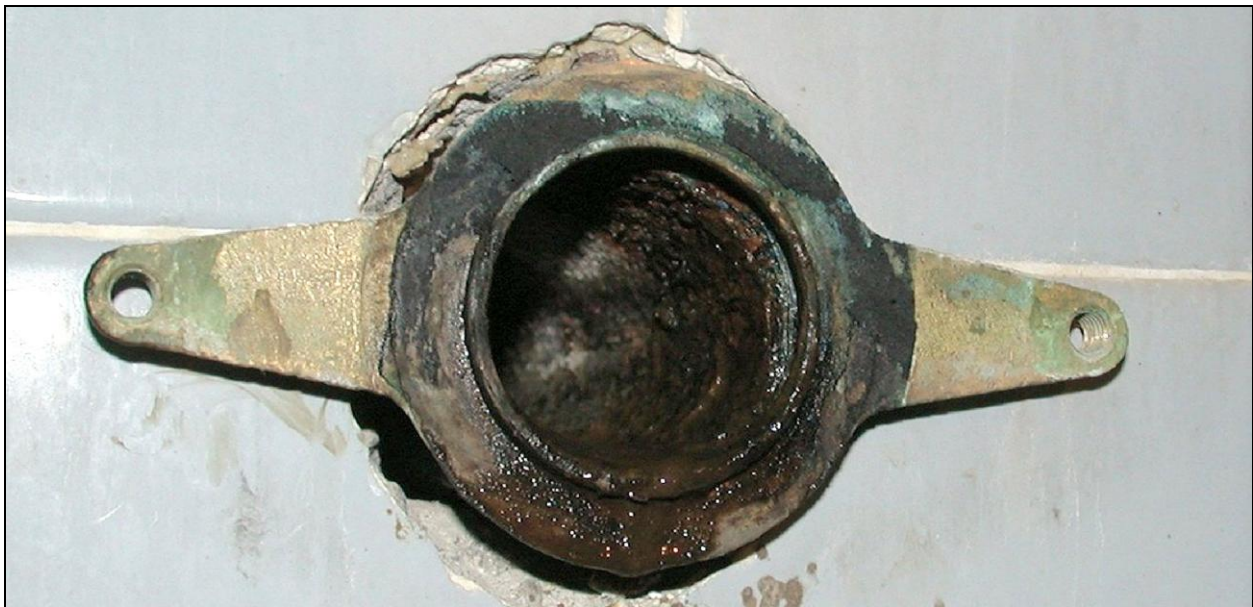
Figure 24. St. Louis County Health Department. Drain line immediately after removing the Falcon Waterfree urinal, after one year of continuous operation. The Falcon Waterfree urinal was reinstalled and continues to be in use at this location.

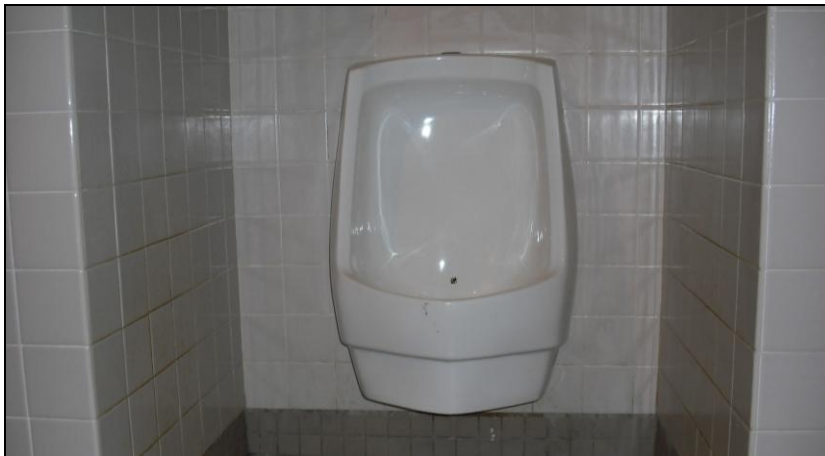
Figure 25. Non-water urinal installed as part of city rebate program in 2001. Typical installation on the fourth floor of this 11-story office building.

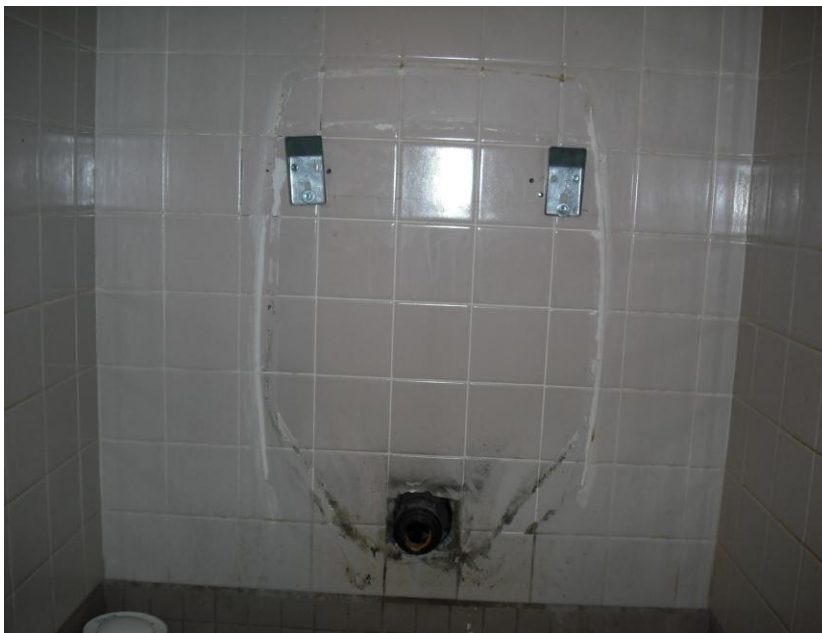
Figure 26. Non-water urinal removed in August 2008 for drain line inspection.

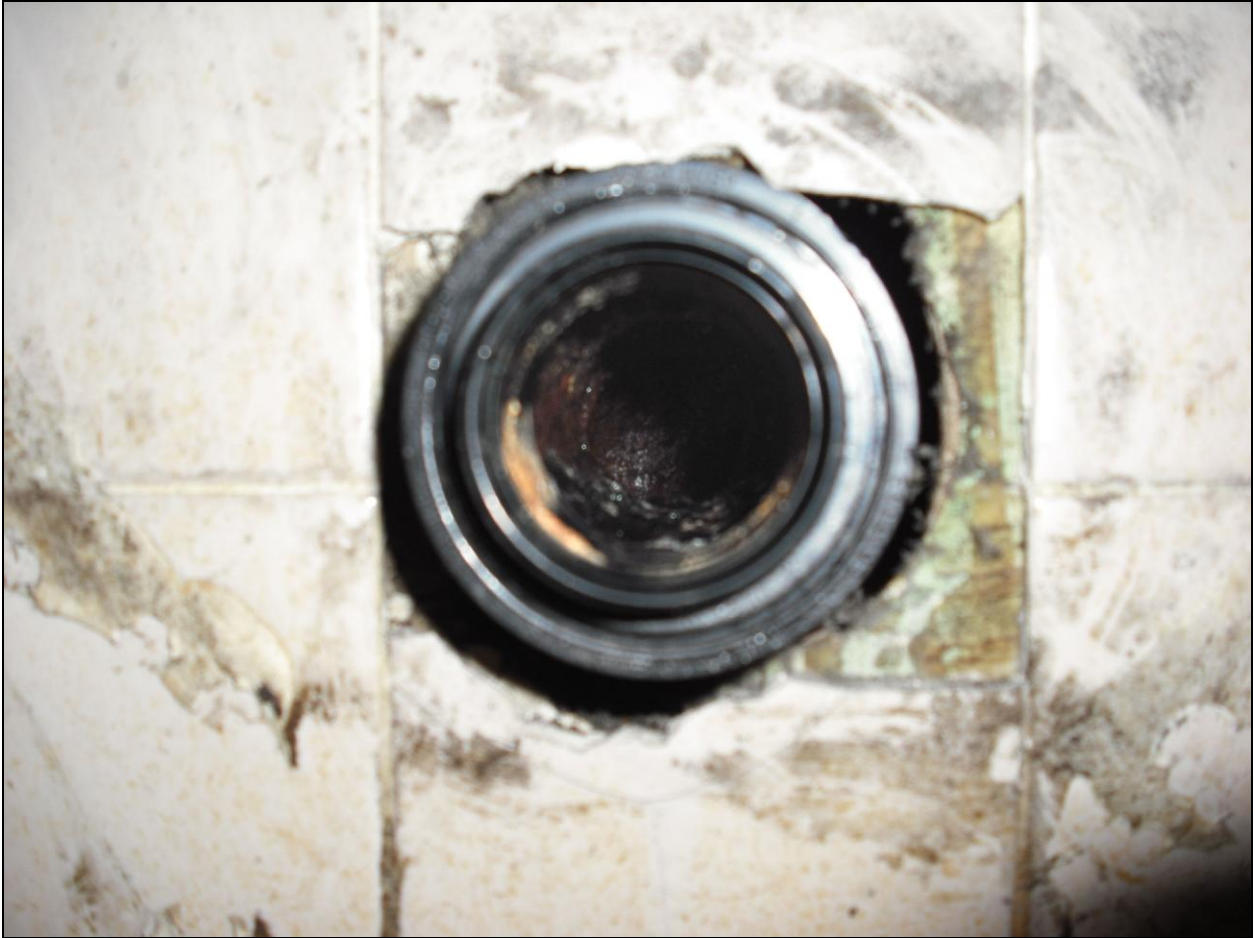
Figure 27. Close-up detail of the horizontal pipe nipple immediately after removing the non-water urinal, after seven years of continuous operation.

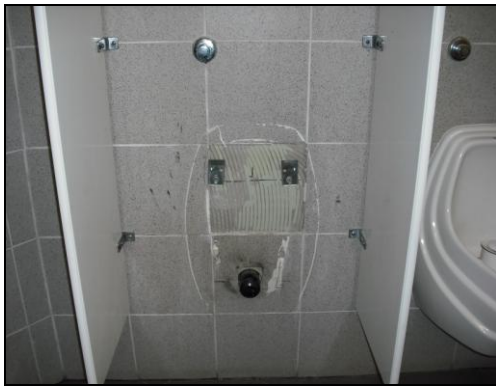
Figure 29. Non-water urinal removed September 2008 for pipe inspection.

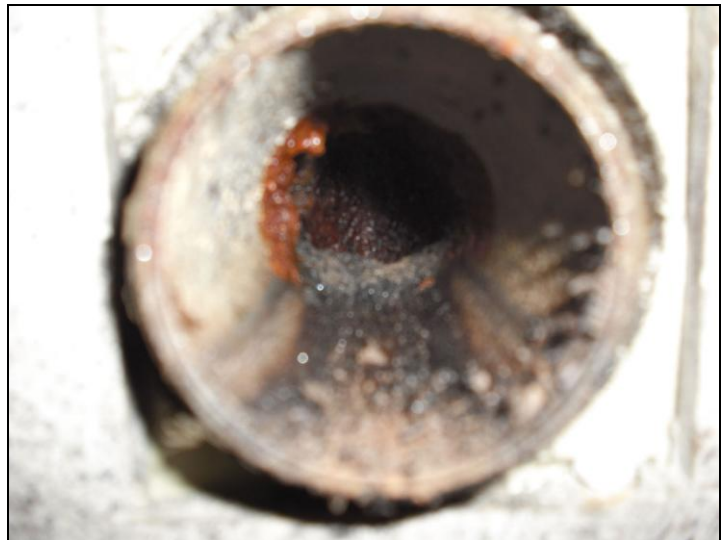
Figure 30. Close-up detail of the horizontal pipe nipple immediately after removing the non-water urinal, after six years of continuous operation.

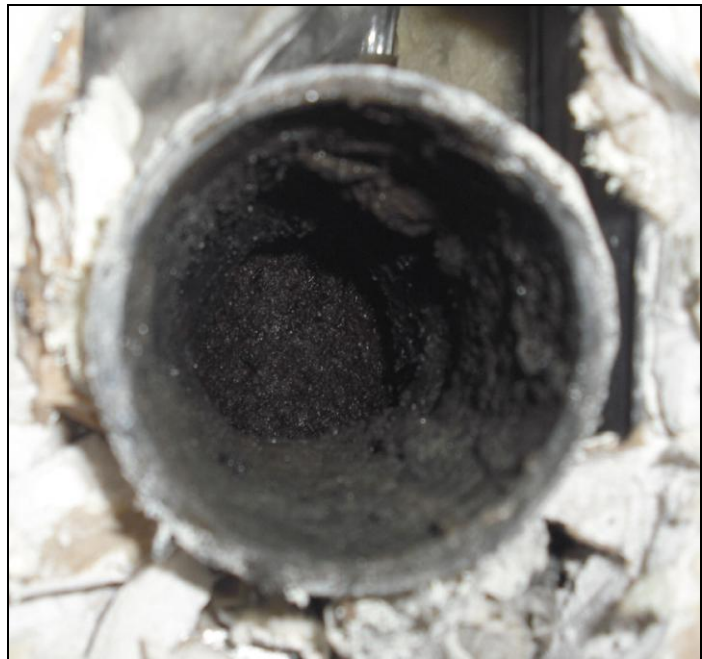
Figure 32. Close-up detail of the horizontal pipe nipple immediately after removing the non-water urinal, after five years of continuous operation.

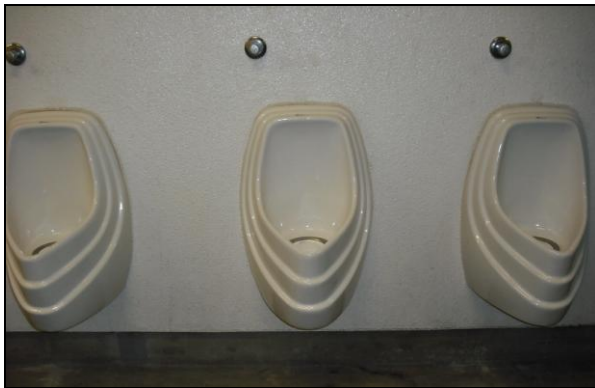
Figure 33. Original installation (retrofit of water-flushing urinal) took place in 2002.
