An Assessment of  
Long-Term Performance of Non-Water (Waterfree) Urinals  
in Relation to Drain Line Buildup

Falcon Waterfree Technologies and  
Sloan Valve Company  
September 15, 2008

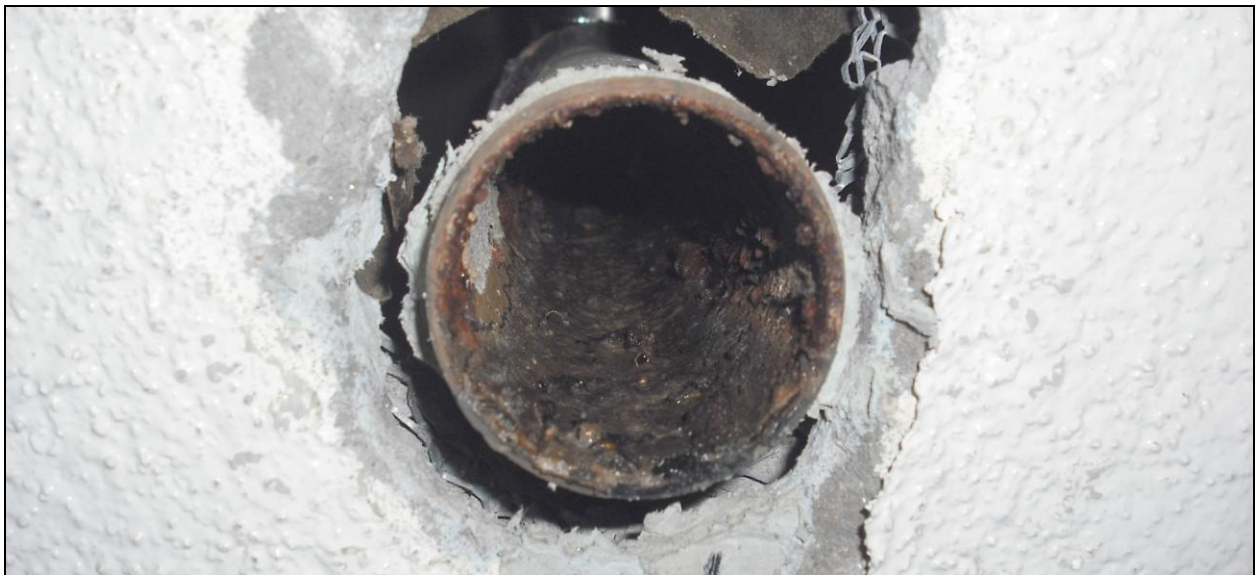
Figure 35. Close-up detail of the horizontal pipe nipple immediately after removing the non-water urinal, after six years of continuous operation.

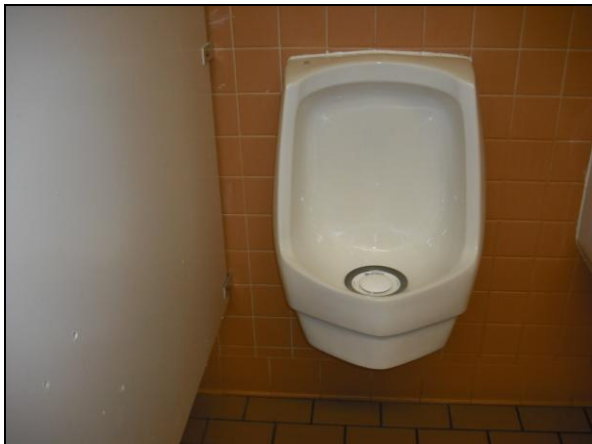
Figure 37. Original installation (retrofit of water-flushing urinal) took place in 2003.

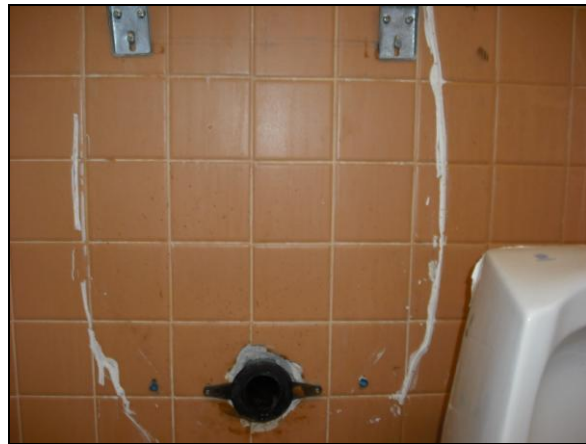
Figure 38. Non-water urinal removed September 2008 for drain line inspection.

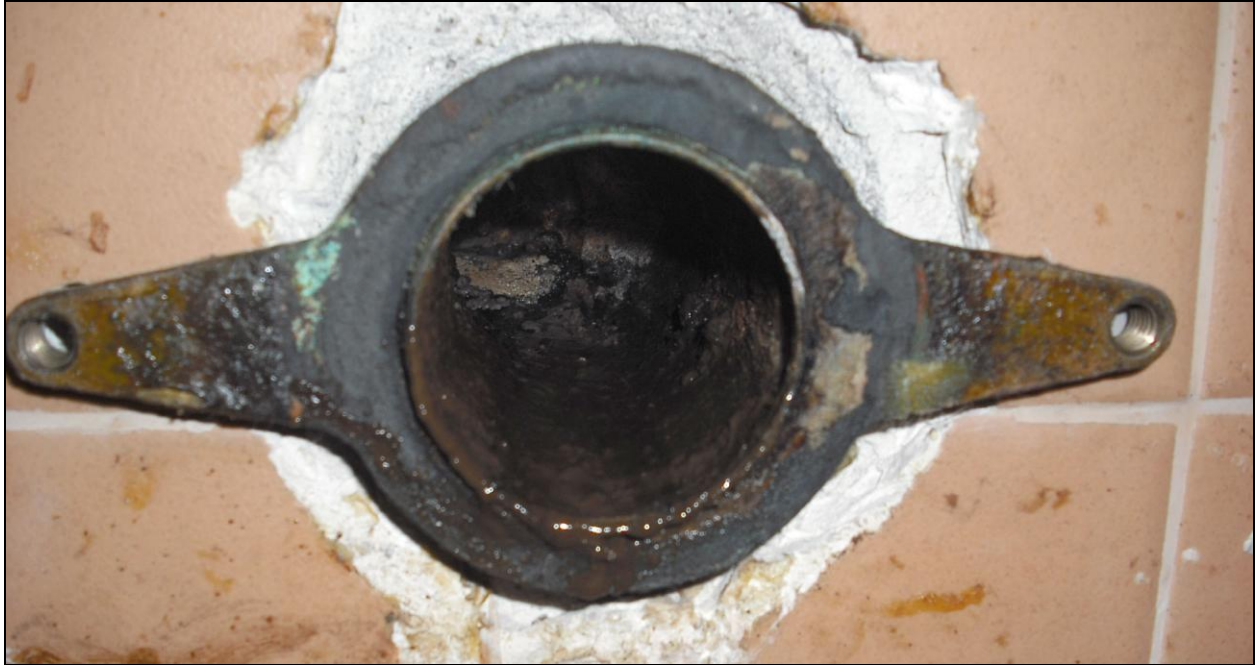
Figure 39. Close-up detail of the horizontal pipe nipple immediately after removing the non-water urinal, after five years of continuous operation.
