# **Long Term Field Evaluation of High Efficiency Urinals at University of Washington**

Draft Final Report – 5/23/11

Roger E. van Gelder, P.E.

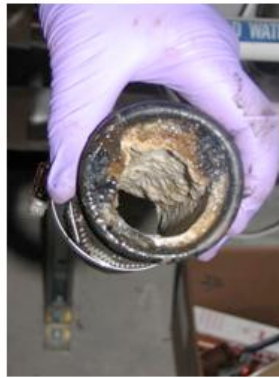
Wall Inlet

Over time, deposits considered unacceptable by UW staff were observed in the waste lines leading from all no-flush and the one pint urinals. Significant buildup was observed in the no-flush urinals after only six months, and occurred in both the horizontal and vertical sections of pipe, with the vertical sections showing the greatest buildup. This indicates that it is not just a case of insufficient slope in the waste line, as has sometimes been suggested. For the pint urinal, buildup after three and a half years was similar to that seen for the no-flush urinals after only

## Waste Line Observations (after 6 months of use)
